# Project Highlights

## Project 1: California Rock and Asphalt

## Project 2: American River Asphalt Reject Dust

## Project 3: Baldwin Construction Doyle Plant

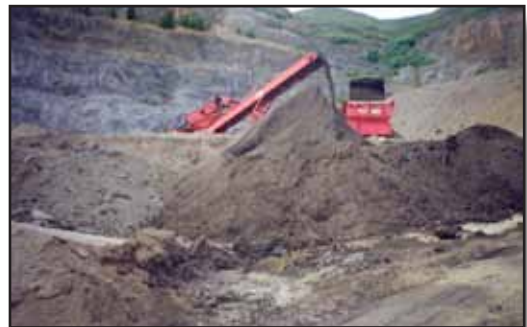
- Soil was first screened to remove large rocks, cobble and debris
- Soil was situated in 1.2 m - 1.8 m deep lifts/biopiles for ex-situ inoculation, nutrient application and moisture maintenance
- Biopiles were situated for easy access from culturing/nutrient tanks and supply hose

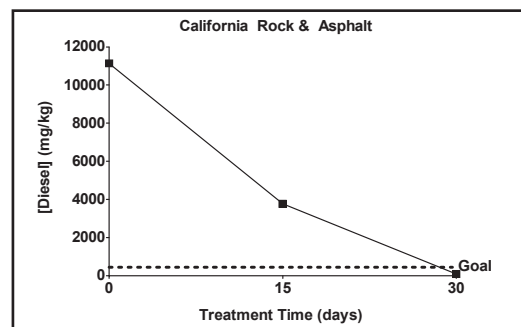
- **Culturing:** Large scale, high density cultures were prepared on-site for 48 hours.
- **Inoculation/Application:** Inoculations were made on day 0 and day 15. Moisture content of piles was monitored and maintained on a daily basis.
- **Duration:** The duration of treatment was based on periodic analytical testing. Based on periodic tests, treatment was stopped at 35 days pending final, official test results.

- Soil was tested on days 0, 15 and 30 by an independent certified laboratory.
- Analytical tests from day 30 returned non-detect for all samples taken.
- Client was able to begin site closure procedures with no further remedial action, and was able to use treated material as backfill.
- Bioremediation provided an effective, rapid, low-cost and non-invasive solution for client.

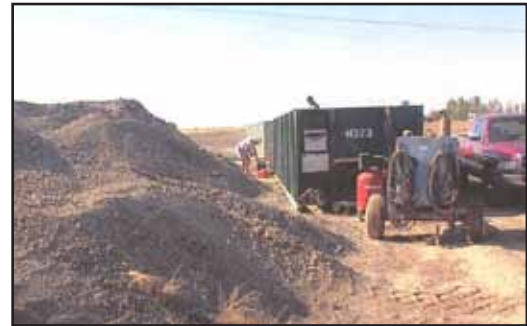
- 1# 500 gallon (1,890 L) primary culture tank
- 2# 10,000 gallon (37,850 L) tanks for inoculation- culture and water storage
- Air compressor for aeration and agitation of culture
- Electric pumps for distribution of microbial consortia and nutrients
- Hoses for distribution of microbial consortia and nutrients
- Generator for remote power supply
- Earth moving equipment for manipulation of soil (supplied by client)
- Water truck for daily watering (supplied by client)

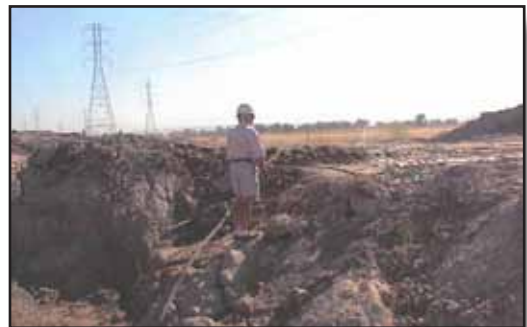
- Soil was situated in 0.9 m - 1.2 m deep lifts for ex-situ inoculation, nutrient application and moisture maintenance
- Soil was situated for easy access from culturing and nutrient tanks, as well as providing easy access for water truck

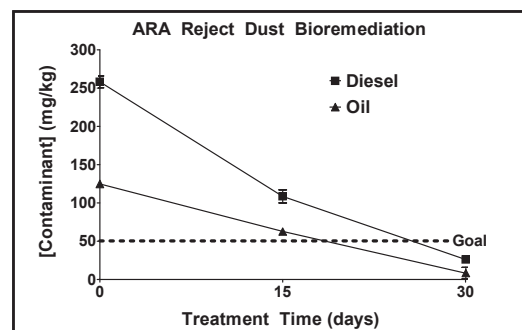
- **Culturing:** Large scale, high density cultures were prepared on-site for 48 hours.
- **Inoculation/Application:** Inoculations were made on day 0 and day 15. Moisture content of piles was monitored and maintained on a daily basis.
- **Duration:** The duration of treatment was based on periodic analytical testing. Based on periodic tests, treatment was stopped at 35 days pending final, official test results.

- Soil was tested on day 0, 15 and 30 by an independent certified laboratory.
- Official analytical tests from day 30 returned non-detect for all samples taken.
- Client was able to immediately begin site closure procedures with no further remedial action necessary.
- Bioremediation provided an effective, rapid, low-cost alternative for the client.

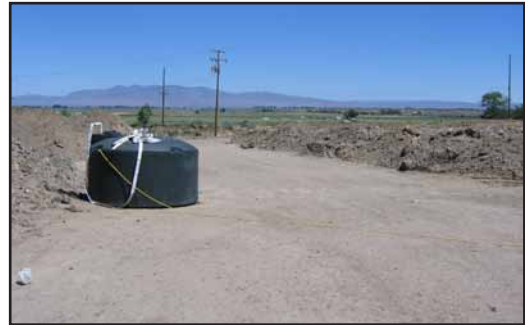
- 2# 1,000 gallon (3,780 L) primary culture tanks
- 2# 1,000 (3,780 L) gallon tanks for inoculation culture and water storage
- Air compressor for aeration of culture and nutrients
- Electric pumps for distribution of microbial consortia and nutrients
- Hoses for distribution of microbial consortia and nutrients
- Generators for remote power supply
- Water Truck (provided by client)
- Earth moving equipment for manipulation of soil (provided by client)

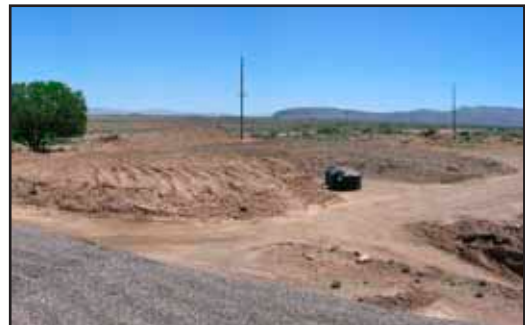
- Contamination was detected to depth of 6 meters. Soil was excavated for ex-situ treatment on site.
- Excavated soil was arranged into four treatment pads from 0.9 m - 1.8 m deep for ex-situ inoculation, nutrient application and moisture maintenance.
- Soil was situated for easy access from inoculation and nutrient tanks, as well as providing access for water truck

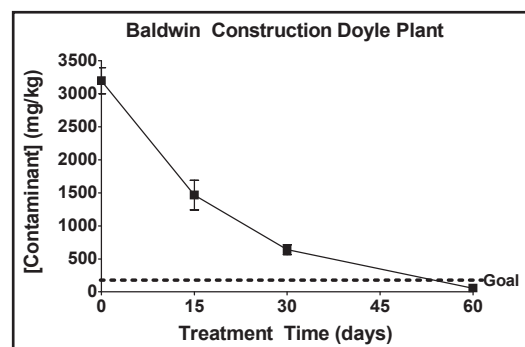
- **Culturing:** Large scale, high density cultures were prepared on-site for 48 hours.
- **Inoculation/Application:** Inoculations were made on days 0, 15 and 45. Watering for moisture maintenance was performed twice a day for 60 days.
- **Duration:** The duration of treatment was based on analytical testing, and treatment was stopped after 30 days pending official test results. Several hot spots (approximately 2% of the contaminated soil) were detected, and soil was treated for an additional 30 days. Treatment was stopped at 60 days pending official test results.

- Soil was tested on day 0, 15, 30 and 60 by an independent certified laboratory.
- Official analytical tests at day 60 returned non-detect for all samples taken.
- Client was able to begin site closure procedures and return material to excavation pits with no further remedial action necessary.

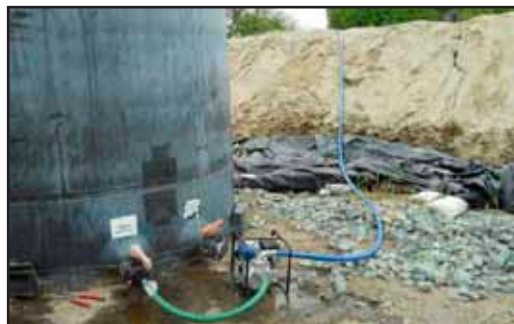
- 1# 200 gallon (756 L) primary culture tank
- 1# 12,000 (45,360 L) gallon tank for inoculation culture and water storage/irrigation
- Air compressor for aeration of culture and nutrients
- Electric pumps for distribution of microbial consortia and nutrients
- Hoses for distribution of microbial consortia and nutrients
- Generators for remote power supply
- Bobcat with 8-inch auger for inoculation wells
- Earth moving equipment for manipulation of soil (provided by client)

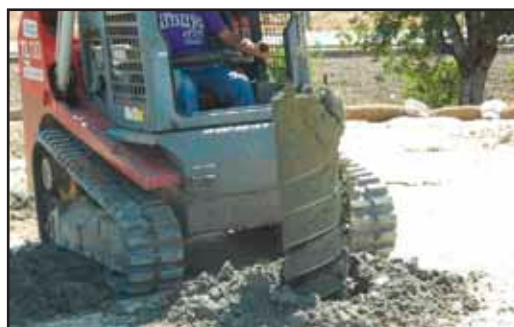
- Contamination was detected to depth of 5 meters. Soil was excavated for ex-situ treatment on site.
- Excavated soil was arranged into one treatment pads ~2.85 m deep for ex-situ inoculation, nutrient application and moisture maintenance.
- ~115 8-inch diameter inoculation wells were drilled into the pile to allow for adequate absorption and dispersion of microbes, nutrients and moisture.
- Pile was covered with visqueen following primary inoculation.

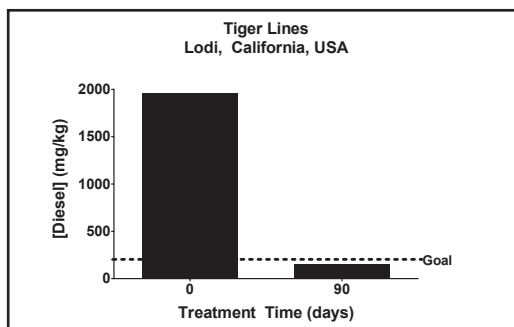
- **Culturing:** Large scale, high density cultures were prepared on-site for one week (8 days).
- **Inoculation/Application:** One, high-density inoculation was made on day 01. Four additional nutrient applications were made on days 07, 14, 21 and 30. Moisture maintenance was performed as determined by daily moisture content evaluations.
- **Duration:** The duration of treatment was based on analytical testing results. Tests conducted on effective day\* 90 demonstrated that the project goal had been met.

- Soil was tested on days 0 and 90 by independent certified laboratories.
- Official analytical tests at day 90 indicated that the project goal had been reached.
- Client was able to begin site closure procedures and return material to excavation pits with no further remedial action necessary.
